WADD TECHNICAL NOTE 60-296

F-102 HIGH-ALTITUDE FLAMEOUTS IN AND AROUND THUNDERSTORMS

Project Nr 201A(1)

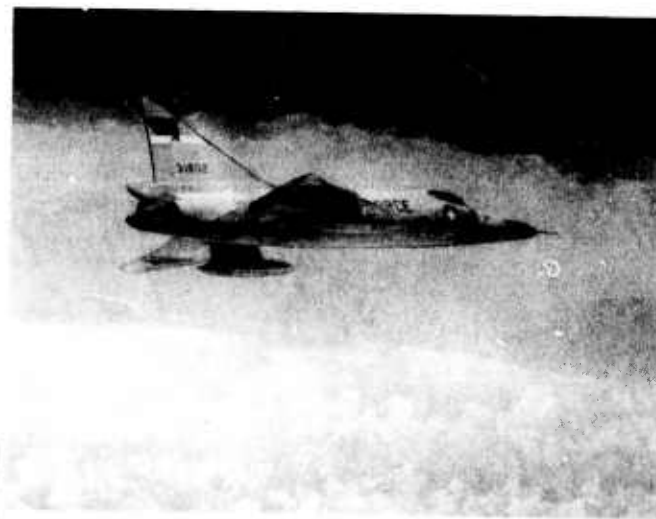
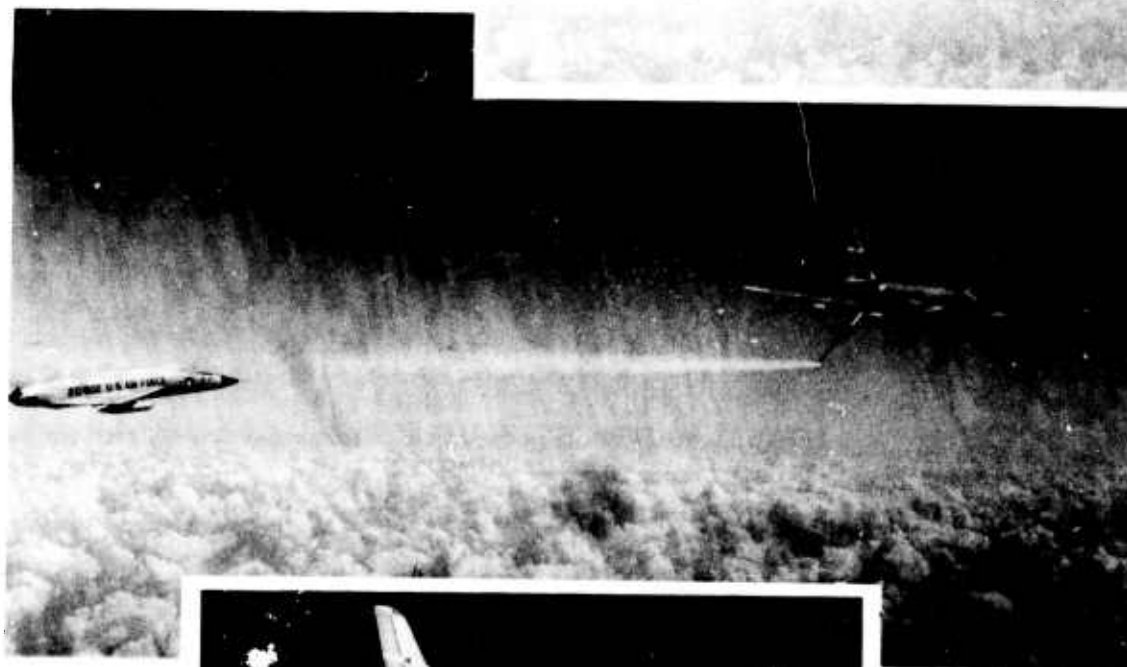
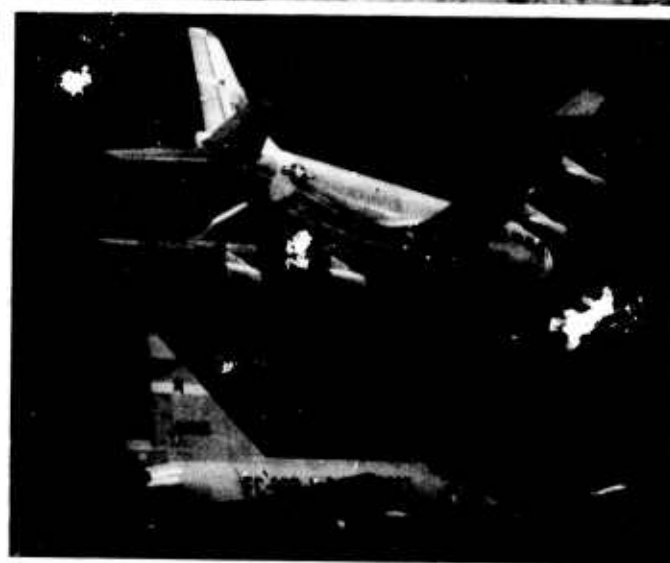
ALTITUDE WAS 40,000 FEET;
AIRSPEED WAS MACH .85.
ICE-CRYSTAL CONCENTRATION
FOR THIS FLIGHT WAS 2.0
GM/CUBIC METER. THE F-102A
WAS 750 FEET BEHIND THE
KC-135.

Figure A1. F-102A flight into the simulated ice-crystal environment created by a KC-135 aircraft in south-central Ohio.

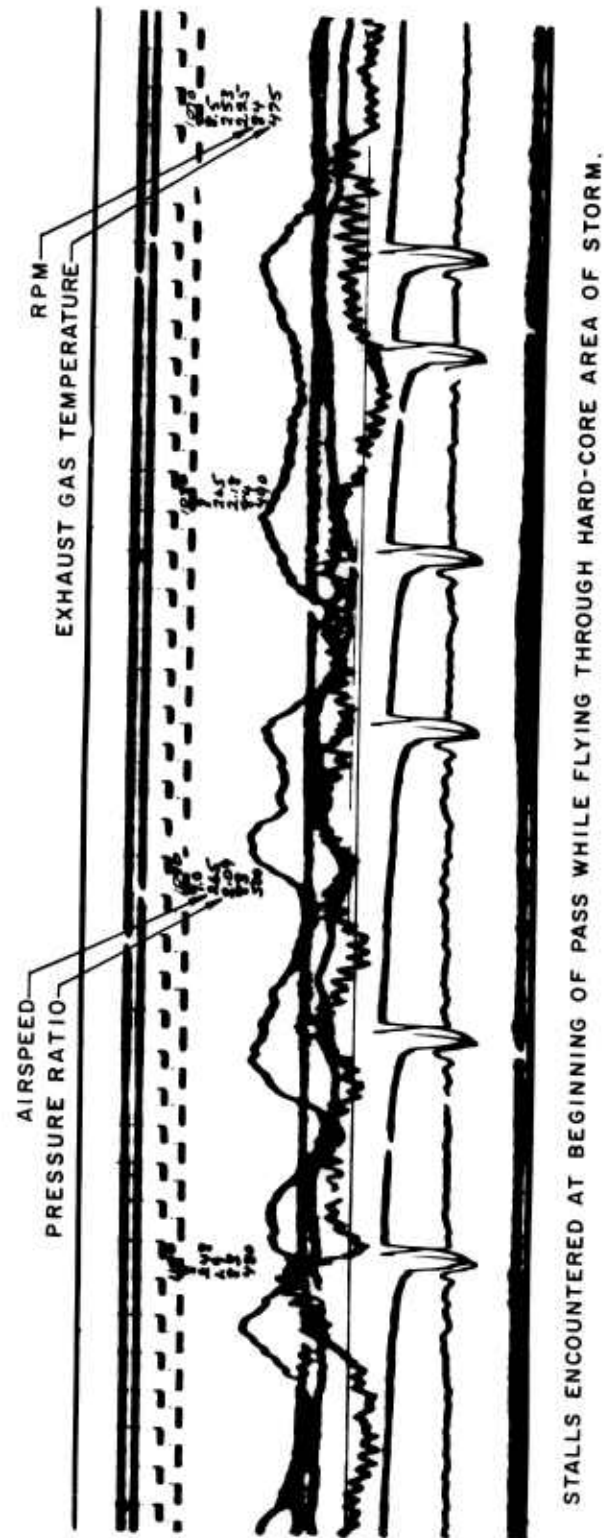
Figure B2. Oscillograph recordings of compressor stalls experienced during Pass Nr 2 of Flight Nr 5, Project "Rough Rider," 27 May 1960. (A total of 241 compressor stalls were encountered on this pass.)

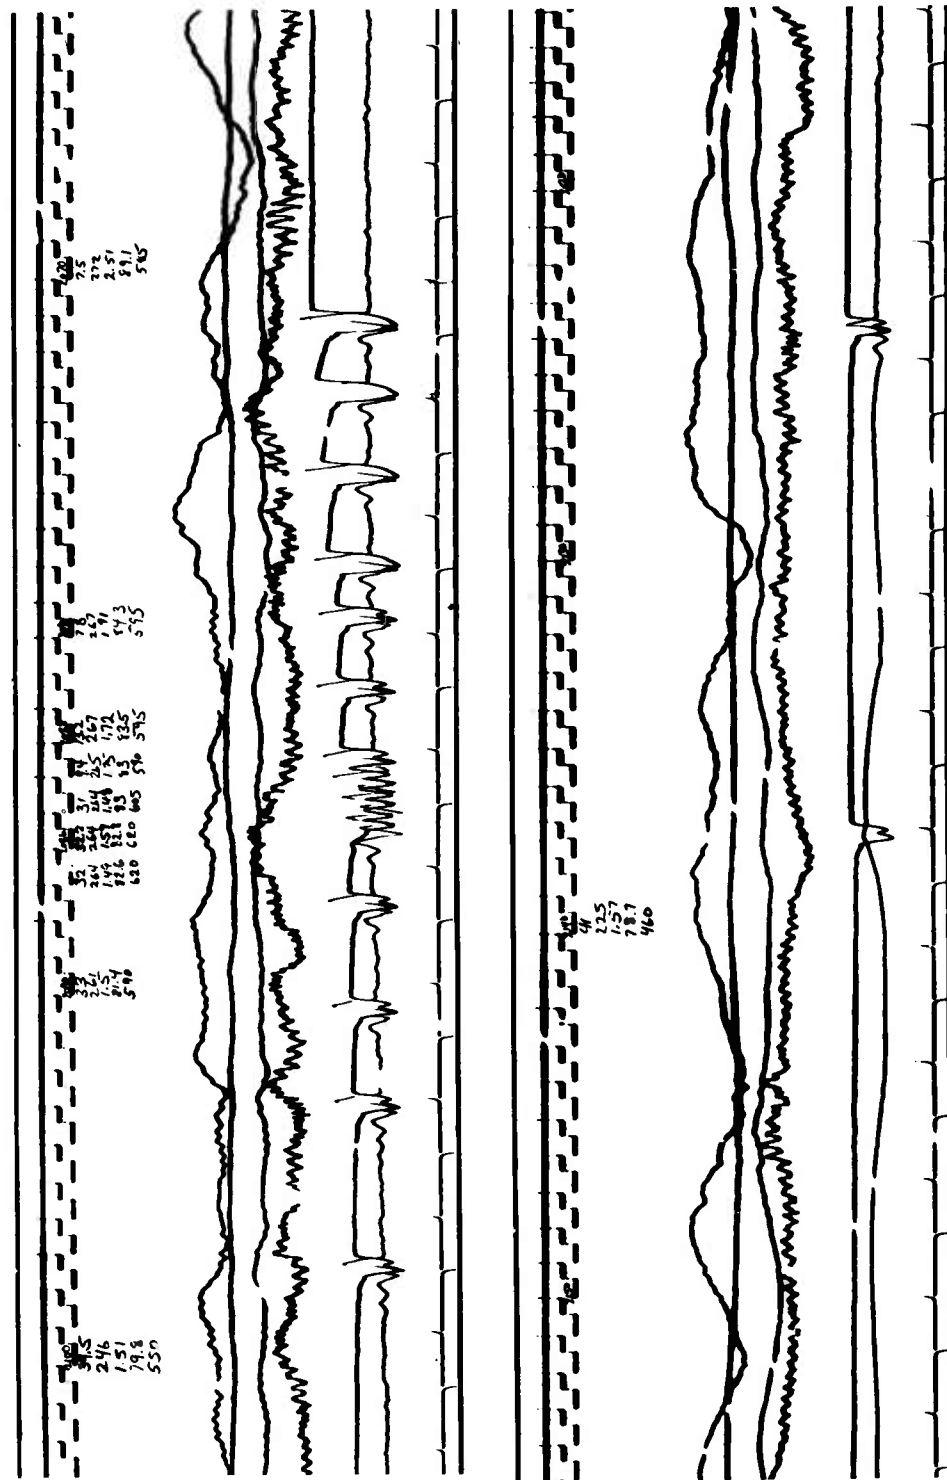
Figure B3. Oscillograph recordings of compressor stalls experienced during Pass Nr 7 of Flight Nr 12, Project "Rough Rider," 27 May 1960.

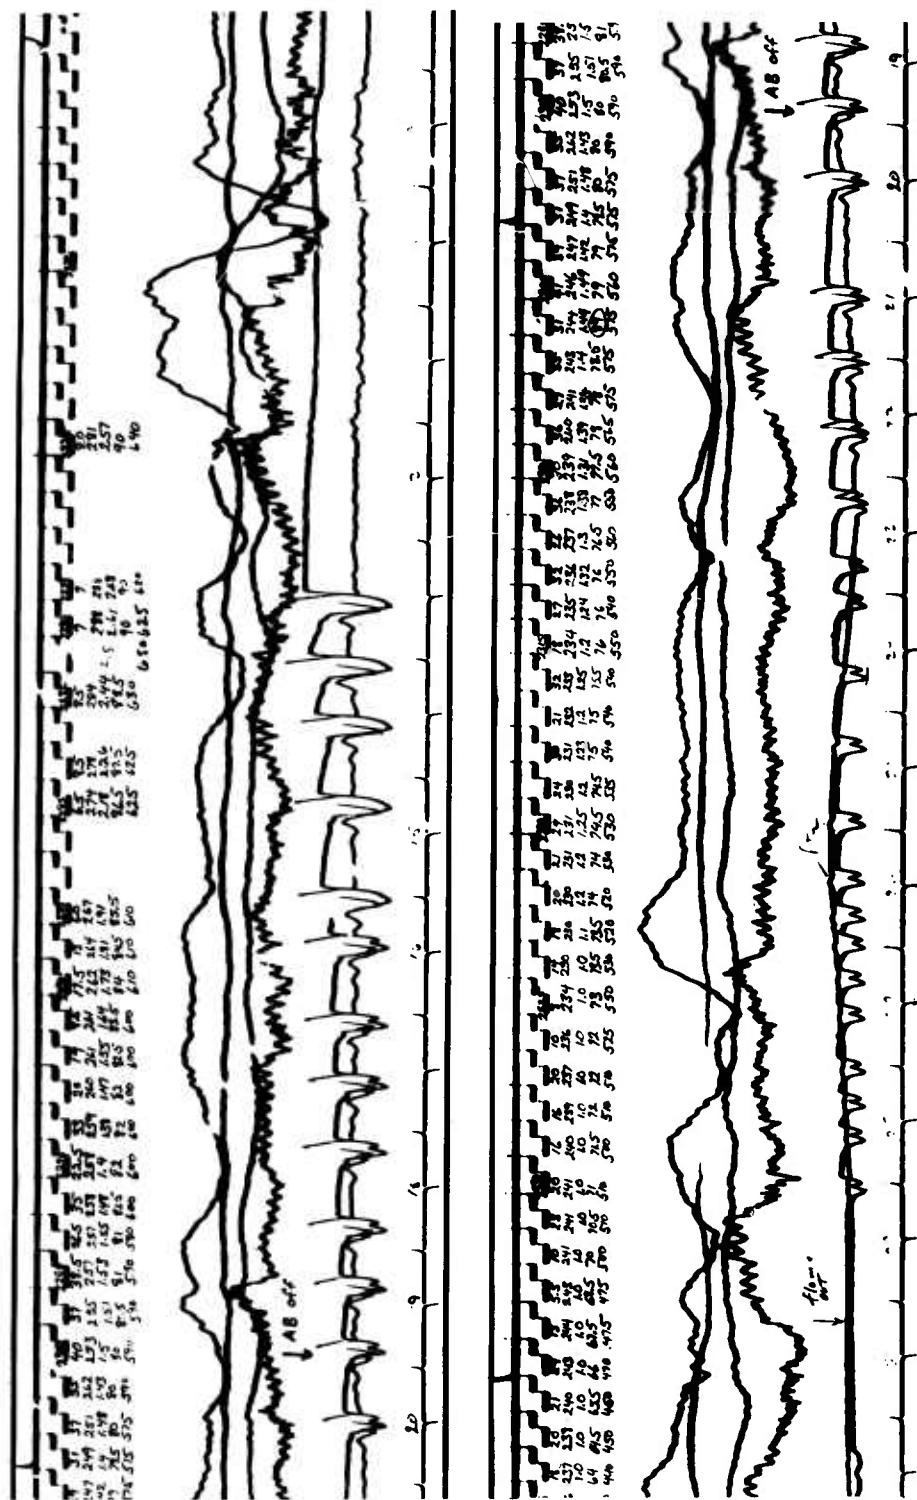
Figure B4. Oscillograph recordings of compressor stalls experienced during Pass Nr 8 of Flight Nr 12, Project "Rough Rider," 27 May 1960.

The following is a direct quotation from a transcript of pilot comment describing the flameout which occurred on Pass Nr 8 of "Rough Rider" flights near Tinker AFB, Oklahoma, 27 May 1960:

"On the last pass, I had the burner going, and with the speed brakes out to keep from going supersonic. In fact, I was playing with the speed brakes to try to maintain around .9 to .92 Mach number. Very shortly after entering the storm, through heavy clouds, the engine started stalling just as it had before with 'military' power. I was in turbulence and had experienced probably a half-dozen stalls or more when I pulled the throttle out of AB into military power. Shortly thereafter, the thing just flamed out. I continued on heading. When the RPM wound down to below 70 percent, I knew the thing had quit, so I pulled the throttle back to idle and then, while still in the storm, selected dual ignition rather than single, and just set up a glide to continue on out of the storm. Broke out about 36,500, as I recall, and the fire never did start again by using the continuous ignition switches. However, I feel sure this was due to the fact that the RPM was still a little bit too high. When the RPM finally stabilized between 25 and 30 percent, I 'stop-cocked' the throttle and turned the ignition off for a few seconds; then made a normal air start using the ignition button on the throttle. The first time I attempted this at about 34,000, it didn't work, so I shut it off again. The second time, it fired at about 31,000. I feel quite sure it would have been impossible to 'deadstick' the thing due to the canopy's and windshield's icing over, which it does on every flight; so it was fortunate that we got the thing started."

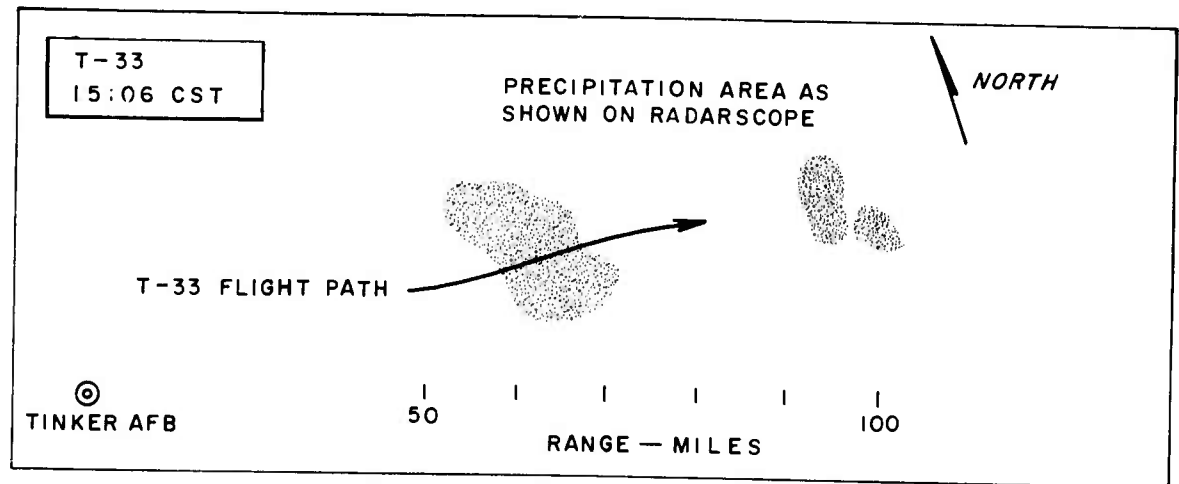
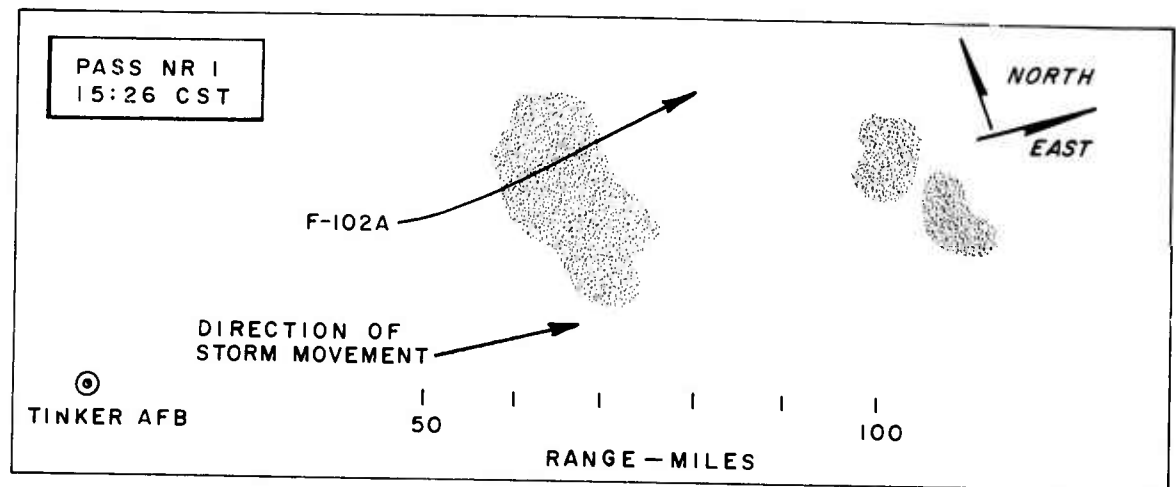
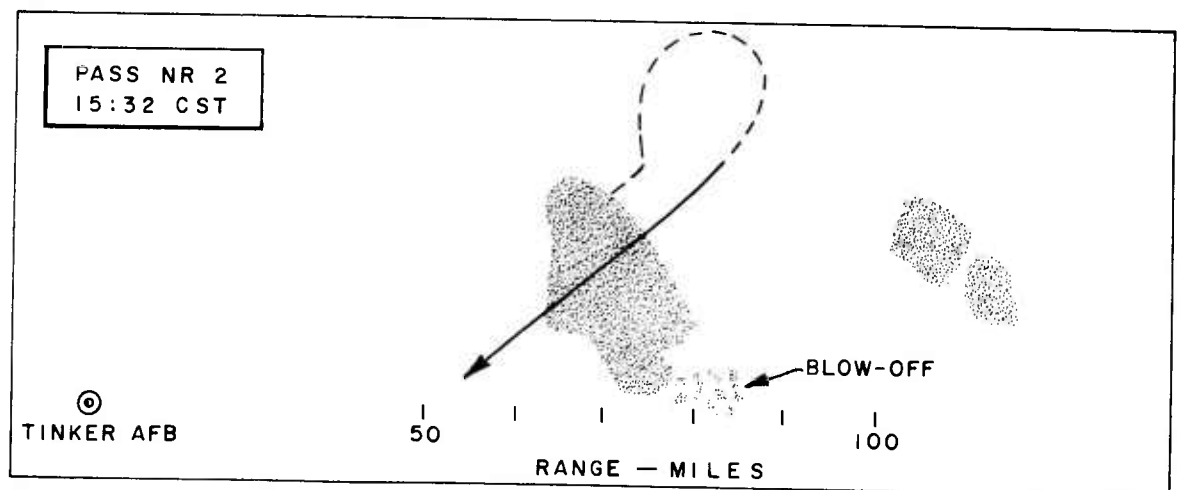
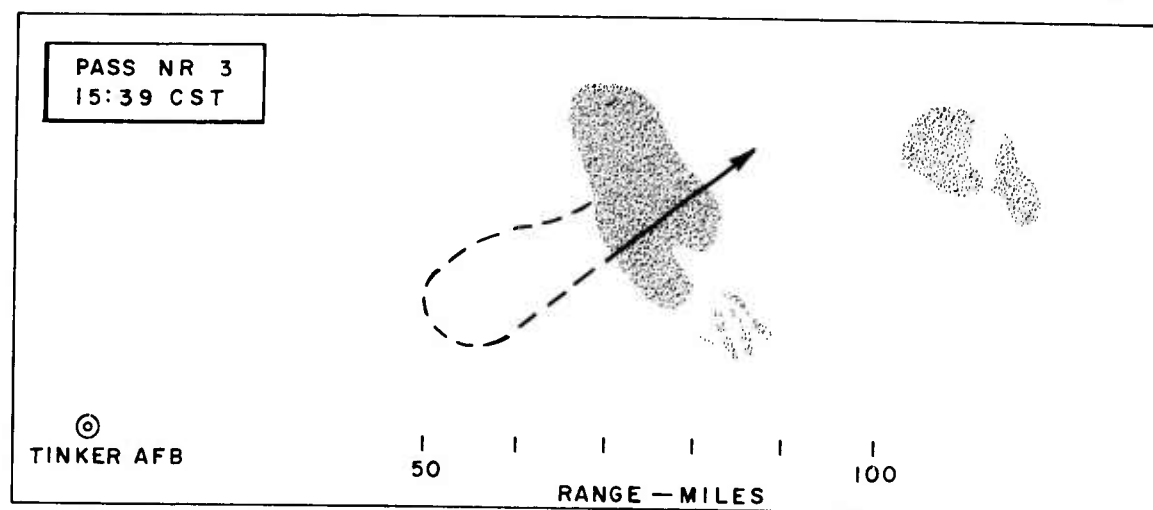
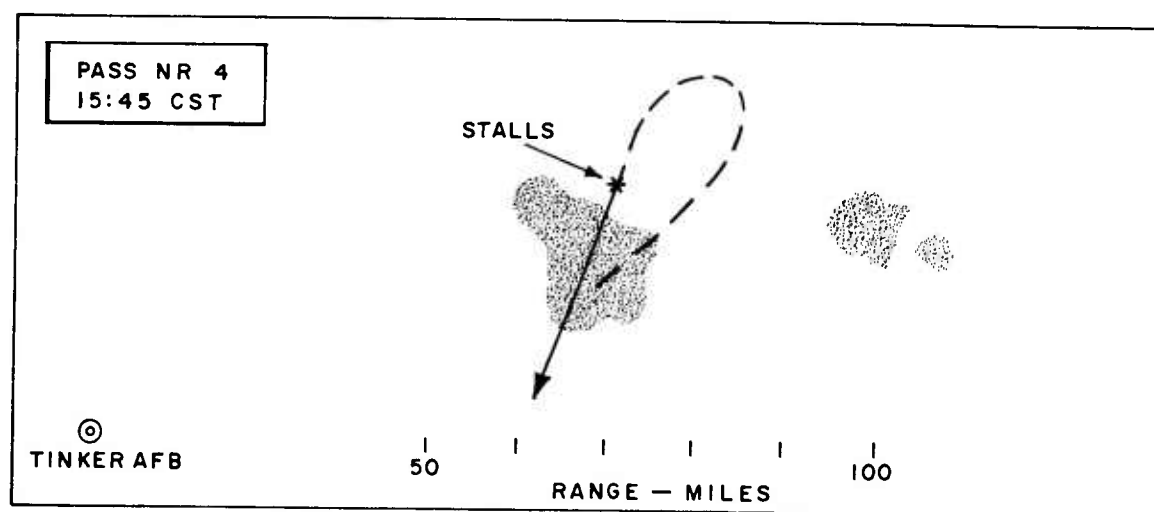
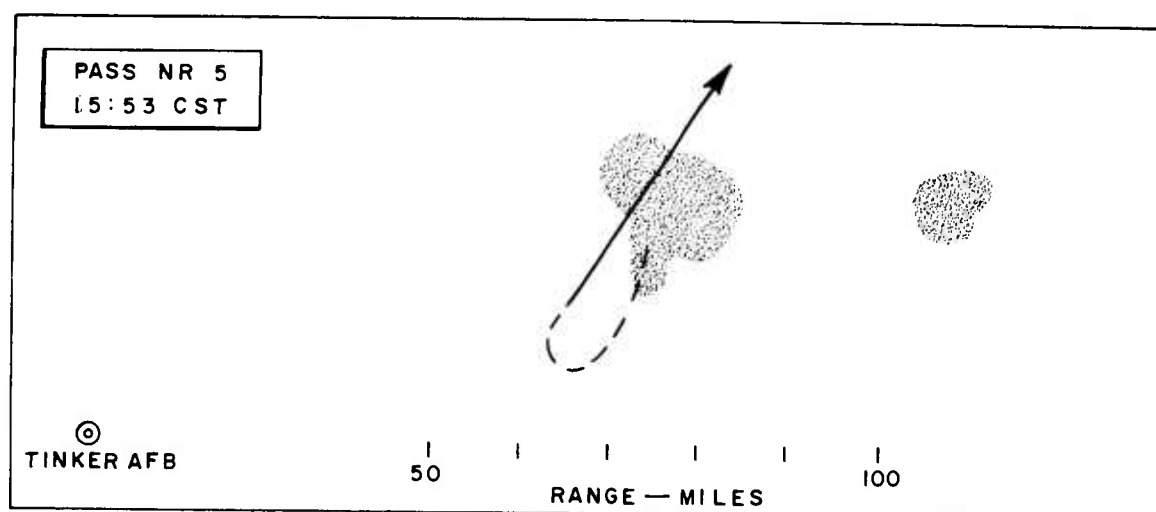
Figure B5. Graphic presentation of F-102A thunderstorm penetrations, Project "Rough Rider," 27 May 1960. (The first illustration shows storm penetration by the NASA T-33 prior to penetrations by the F-102A. If hail had been encountered, the F-102A would not have entered this particular storm.)

SUMMARY OF IMPORTANT F-102A THUNDERSTORM PENETRATION DATA
OF EACH PASS SHOWN IN FIGURE B5

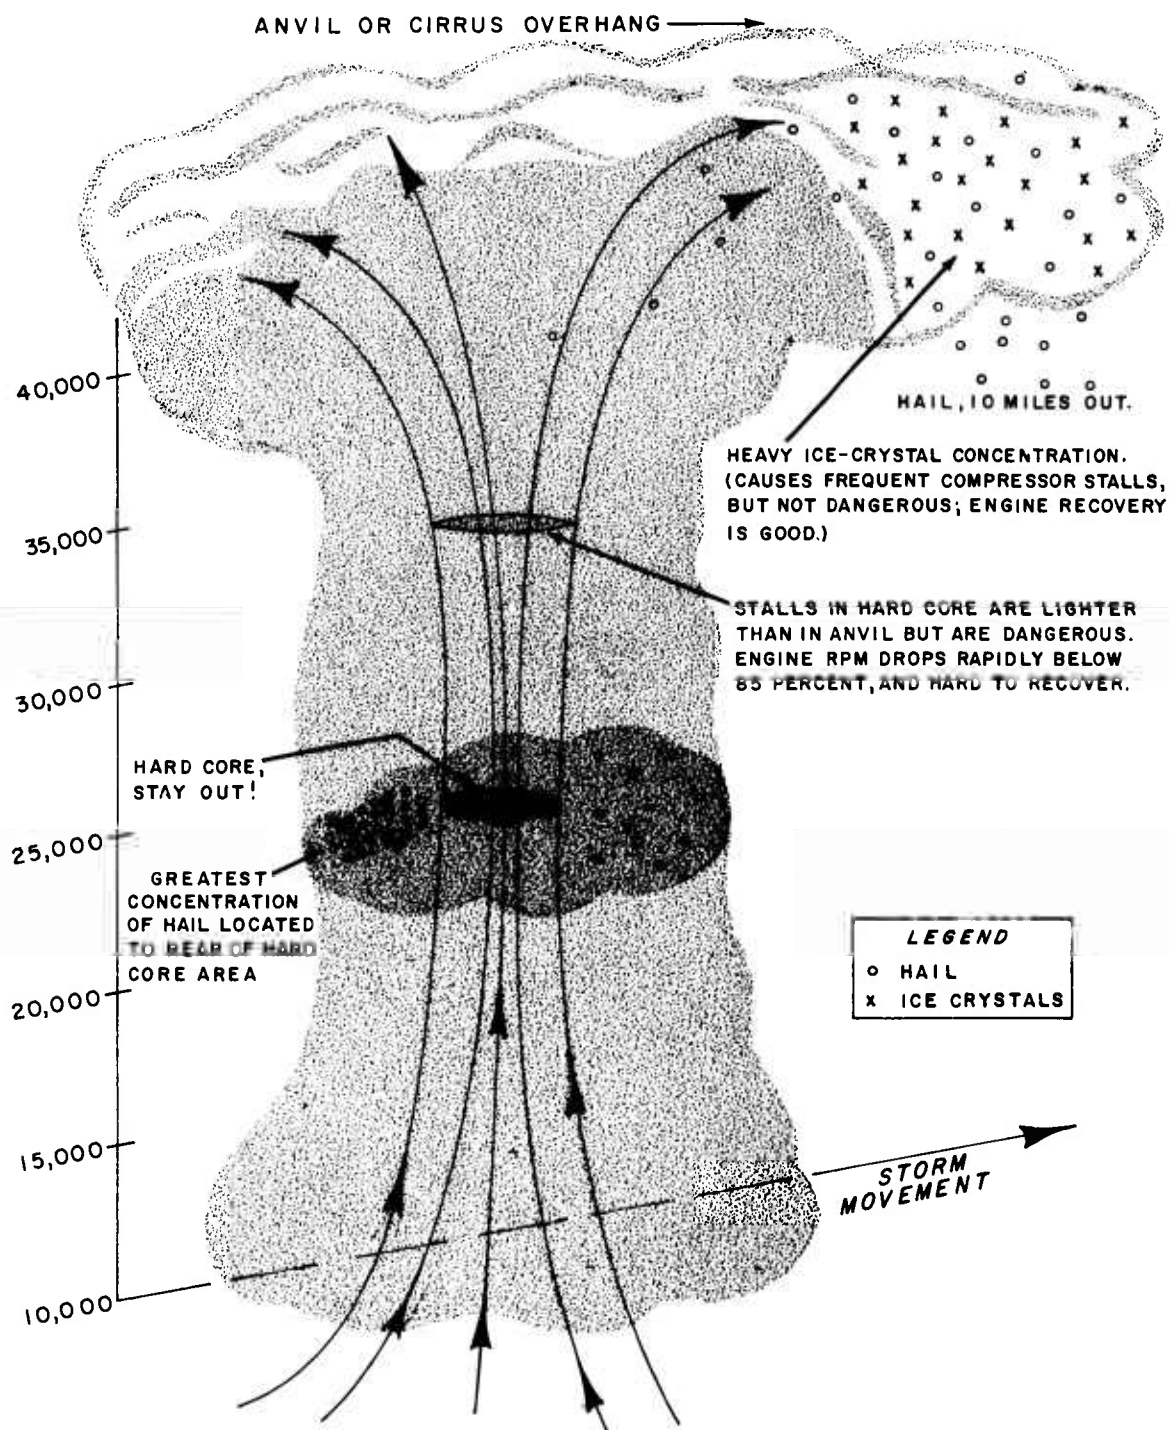
27. Experience has shown that most thunderstorms have a horizontal cross-section as shown in Figure 6. The greatest turbulence in these storms was found in the core (or area of greatest precipitation). Project pilots could only describe the precipitation in this area as "slushy moisture." It was probably a mixture of ice crystals, light rain or freezing rain, and soft hail. Hail was encountered mostly in the core, but was found many times downwind of the core. (During one penetration, radar returns indicated development of a tornado about 10 miles from the flight path of the aircraft. Tornadoes were quite common during this season of the year and every precaution was taken to avoid them.)

Figure B7. Thunderstorm cross-section, Project "Rough Rider," 27 May 1960.
